PORTICO GP SURGERY
Linscott Road,
Hackney, London
E5 0RD

**STRUCTURAL REPORT – DEMOLITION
AND EXCAVATION**

Job Number – LP1329

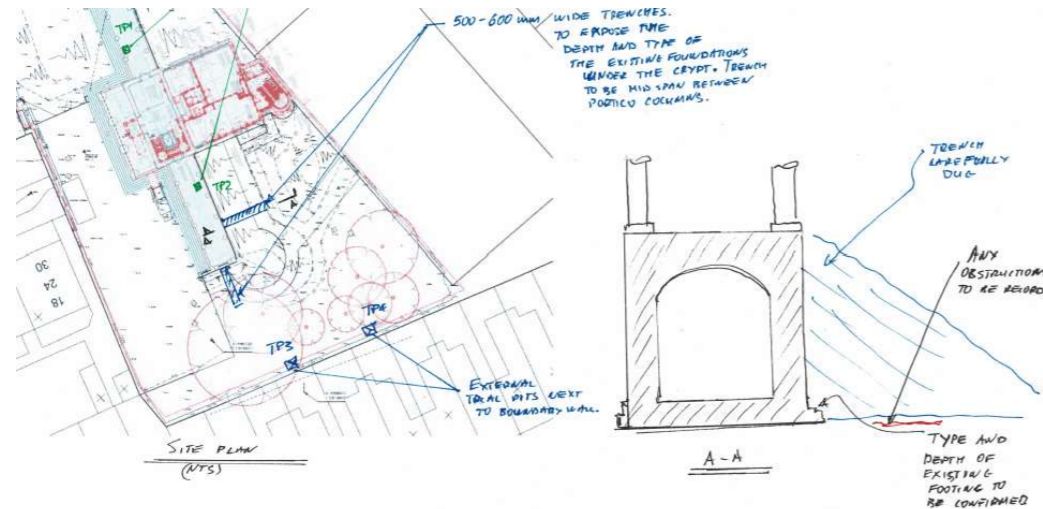
Figure 5 – Exposure Works Requested

With the external levels currently sloping away from the colonnade/portico the main consideration prior to excavation commencement in the area is whether the soil provides lateral support to the masonry structure forming the crypt. In order to confirm the assumption that the fill has been added later and the existing construction, KPT Design requested exposure works on site. A strip of the fill has been removed as per the provided sketch and the area reviewed on site. The following was observed on site:

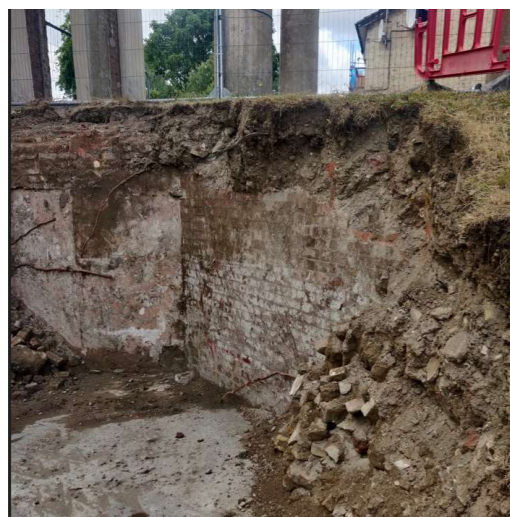
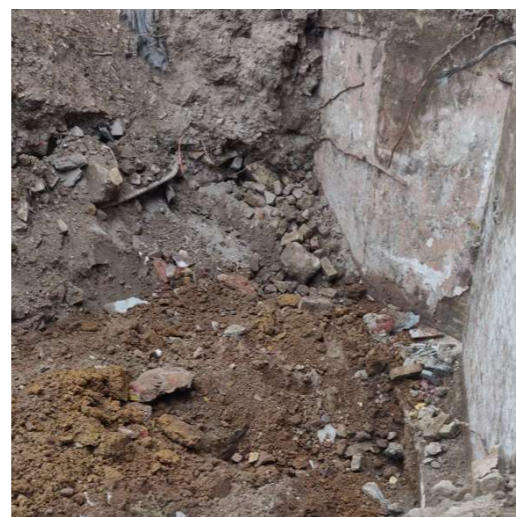
Figures 6 and 7 – Exposure Works Findings

- The regrading of the site has been done with made ground and most of it is containing debris from the removed buildings on site.
- Newer structure has been constructed in the internal courtyard at Basement level at some point. New masonry wall has been added next to the crypt walls and new concrete slab.
- The thickness of the original crypt wall has not been confirmed, but we assume that it projects around 150 mm further than the edge of the round/rectangular columns forming the colonnade.
- The strip on the south side of the crypt was not done due to site constraints at the time. Considering that the original building in the area was part of the original construction the wall forming the crypt was shared between the basement levels and we do not expect new structure in the area.

Based on the site findings and the reviewed information we consider that the excavation can continue in safe manner to the bottom of the existing footings. KPT Design should be informed immediately if anything different is found on site. With the additional information received the proposals in the new courtyard has been amended to avoid undermining the existing structure and to limit any potential damage. This is achievable as the new structure is located further back from the crypt. To the south side special consideration is given to constructing the new building.
