LP1329 - PORTICO GP SURGERY, LINSCOTT ROAD

ADDENDUM TO STRUCTURAL REPORT – DEMOLITION AND EXCAVATION

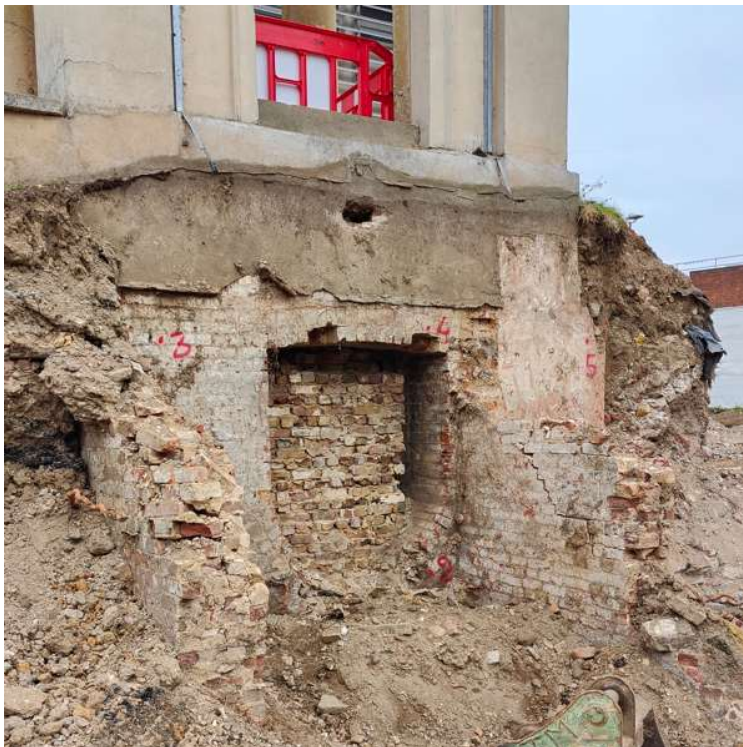
As part of the agreed sequence the south wall of the crypt was exposed externally, and the foundations depth and type were exposed/confirmed. It was also noted that there is an existing arch which has been previously infilled with masonry internally. The thickness of the infill does not match the thickness of the wall and at the top there are gaps between the masonry arch and the infill wall next to it. Please refer to the photograph below

Photograph 1 – Site findings at the South of the Crypt/Colonnade

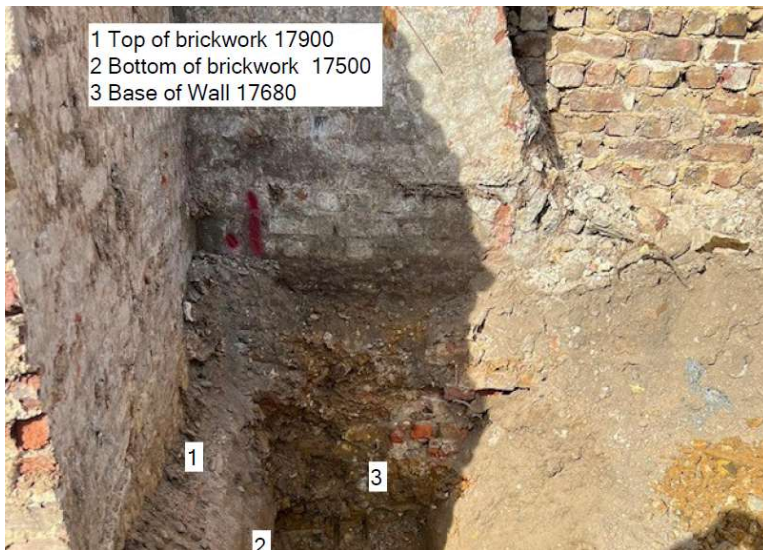
The level of the foundations was confirmed to be at 17.480 after carefully exposing the existing footings.

Photograph 2 – Level of the Existing Footing under the South Wall of the Crypt

The site findings confirmed that the footings in the area are above the structural slab level in the area next to the lift of the proposed building which is 17.335 and that underpinning will be required for the area. For the underpinning to be done in safe and effective manner the full width of the wall has to be underpinning. Considering the load paths and the structural integrity we have specified that the exposed arches should be bricked to the full width of the prior to any underpinning. This will ensure that the loads are transferred to the footings and the new underpin without relying on old arch. At the top of the new and the existing masonry infill well rammed drypack should be appropriately installed. Please refer to the photograph below with the work in progress from site.

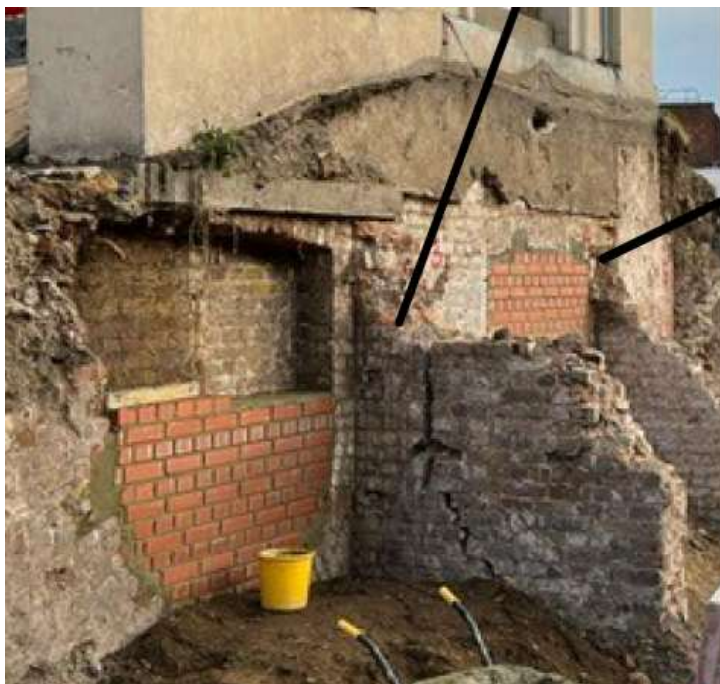
Photograph 3 – Remedial Works at the South of the Colonade

After the remedial works are installed the masonry walls projecting south of the crypt can be carefully removed and the walls should be underpinned to ensure that they are not undermined. Please refer to the sketch below for the proposed structural solution in the area.

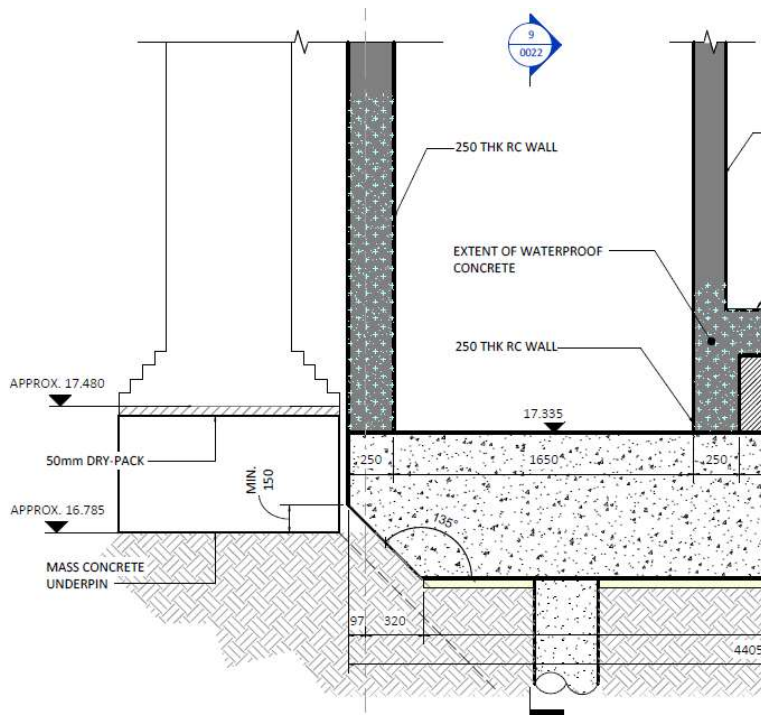
Sketch 1 – Structural proposal next to South Wall of the Crypt

With the suggested detail we consider that the existing structure will be appropriately supported, and the structural integrity is not affected. As the loads to the existing building are not changed, we do not consider that any settlement will appear under the new underpin and we do not expect any damage to the existing structure.
