**TREE DEVELOPMENT REPORT**

(BS5837:2012 ARBORICULTURAL IMPACT ASSESSMENT)

<b>OUR REFERENCE</b>	186879
<b>CLIENT</b>	Edgley Design
<b>PLANNING AUTHORITY</b>	Hackney Borough Council
<b>SITE</b>	64 Middleton Road
<b>SURVEY &amp; REPORT BY</b>	Paul Roberts
<b>DATE</b>	17 <sup>th</sup> December 2021

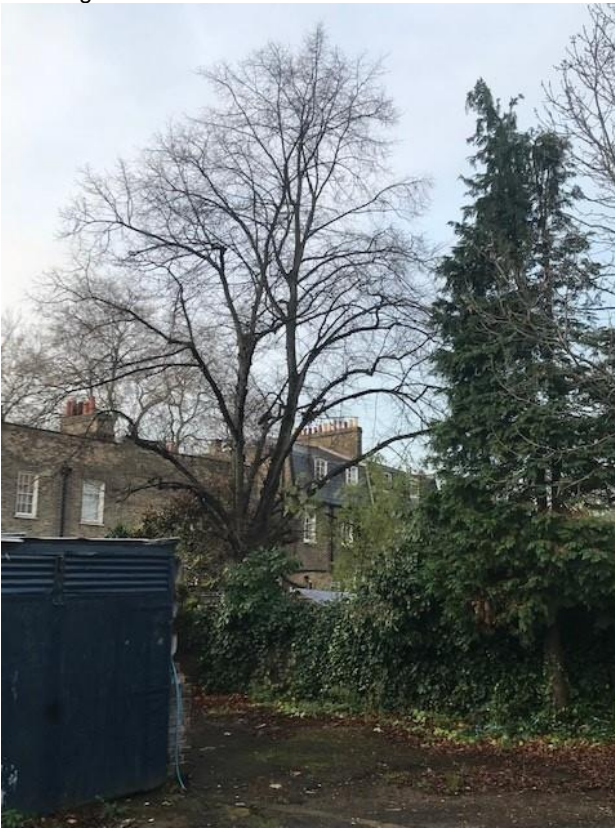
Photograph 1: Showing trees T1 to T2 and the existing hard standing.

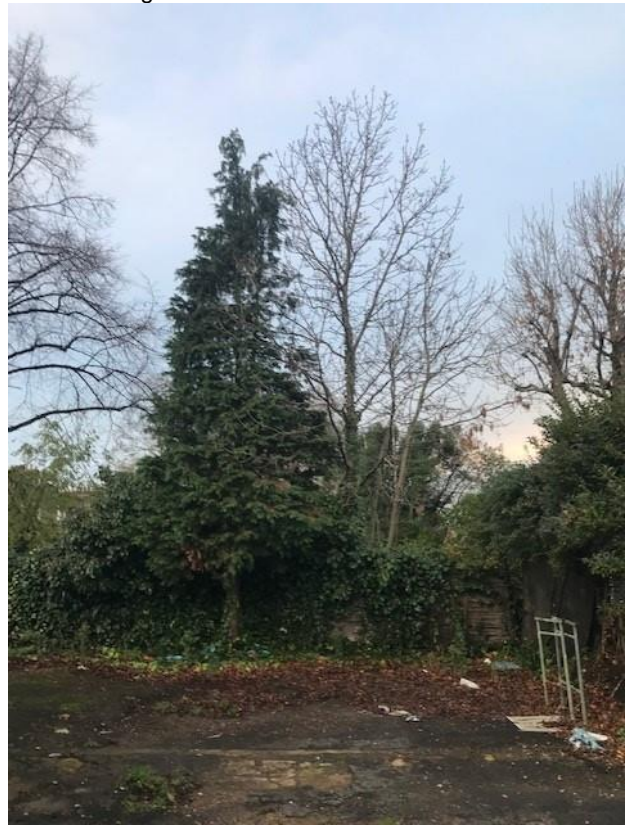
Photograph 2: Showing tree T2 and T3 and the existing hard standing.

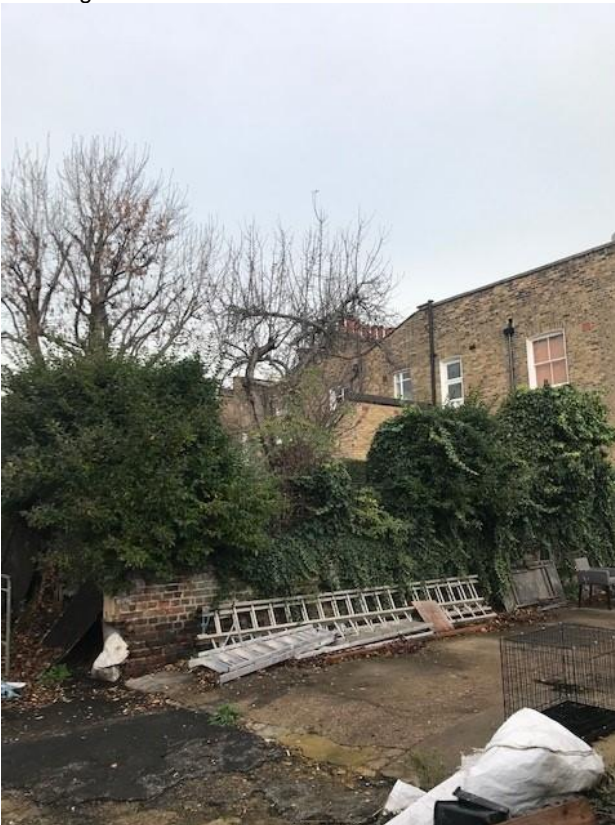
Photograph 3: Showing tree T4 and the existing hard standing.

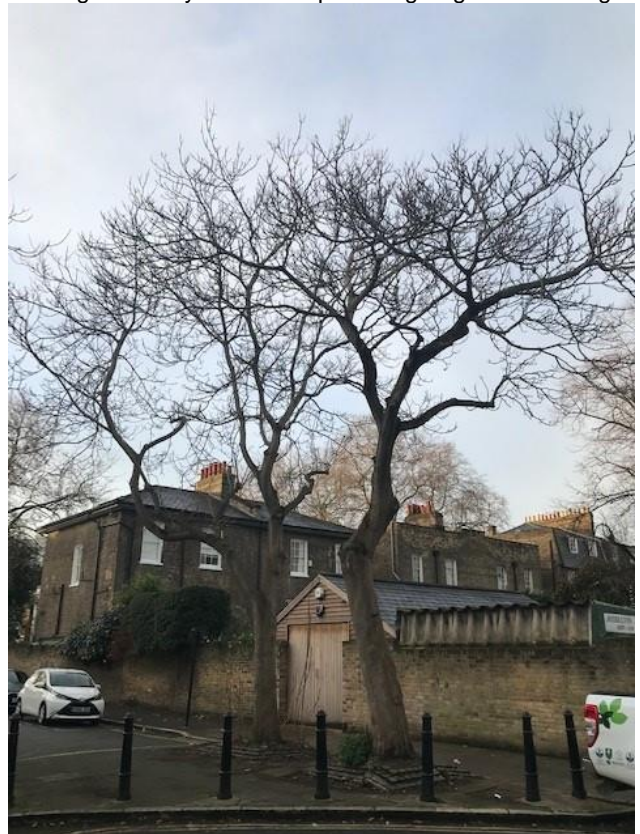
This notes that there would be some minor conflict between trees T5 and T6, however both trees have been significantly lifted in the past and minor works of selective branch removal and appropriate design in the construction will alleviate these issues.

The crowns of trees T5 and T6 will be close to or oversale the proposed development by up to 0.4m. However, both trees have been significantly crown lifted in the past and selective branch removal will pull the crowns back away from the property. In addition tree T<sup>^</sup> has a large area of bark loss on the west side which limited the trees longevity.

Photograph 4: Showing trees T5 and T6 along with the existing boundary wall and top of the garage like building.

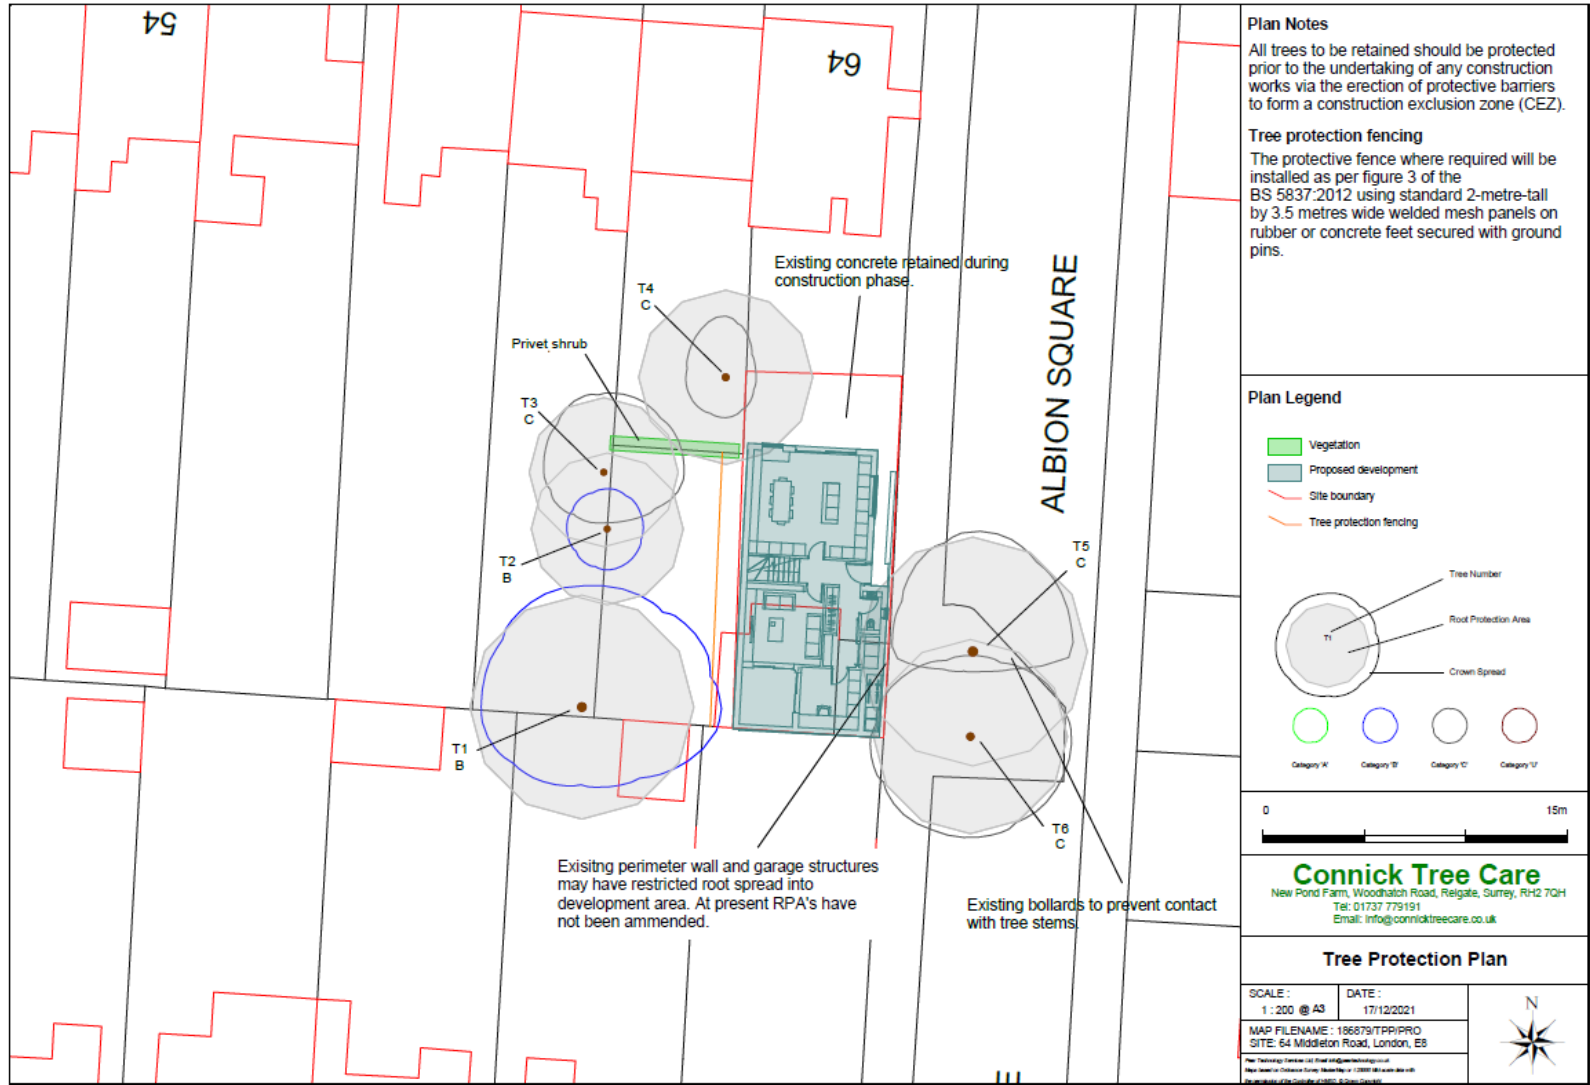
## APPENDIX III TREE PROTECTION PLAN

The survey process and the Tree Protection Plan (Appendix III) has indicated the extent of the theoretical Root Protection Areas (RPA) and crown spreads of the surveyed trees in relation to the development and identifies the potential impacts resulting from the proposed development. The details of the impacts caused by each construction stage is identified within Table 1 below:

The necessary protection measures are identified within the Tree Protection Plan attached as Appendix III.
