Curtain Road Properties Ltd

**Supplementary Pre-Commencement Noise & Vibration
Testing - 118 Curtain Road & 120-124 Curtain Road**

Acoustic Report

11666526 v3 – March 2022

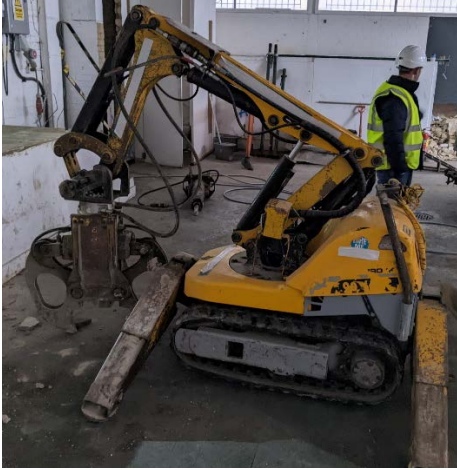
A4.1: Brokk 90 – Hydraulic Breaker

Item	Type	System pressure	Max Noise Level
Hydraulic breaker	Brokk 90	16.5 MPa	L _w 86 dB(A)
Diamond (Stitch) core drilling system	Hilti DD350	6 bar (max)	L _p 95 dB(A)
Percussive Breaker	Hilti TE-1000AVR	-	L _p 85 dB(A)
Diamond Blade Floor Saw	Tyrolit Hydrostress	-	L _w 96 dB(A)

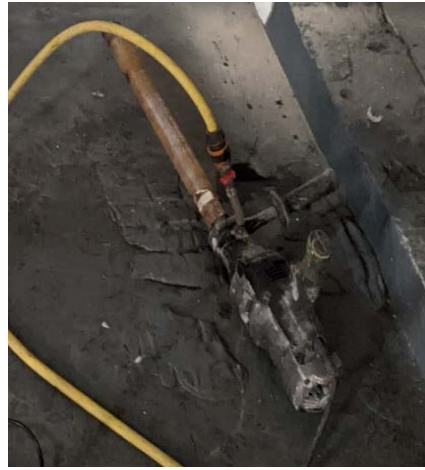
A4.2: Column Coring

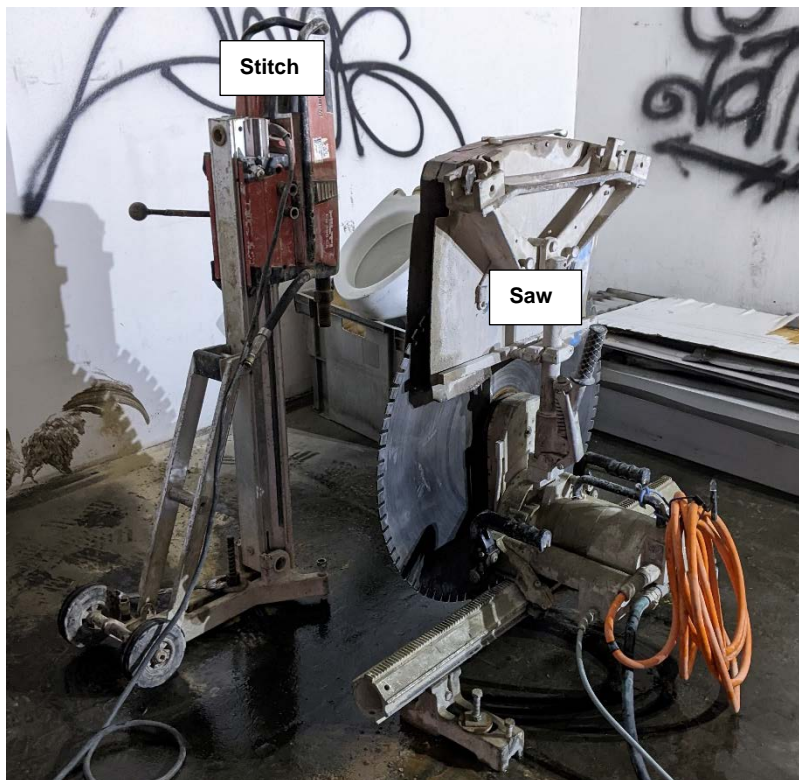
A4.3: Stitch (core) Drill and Floor Saw

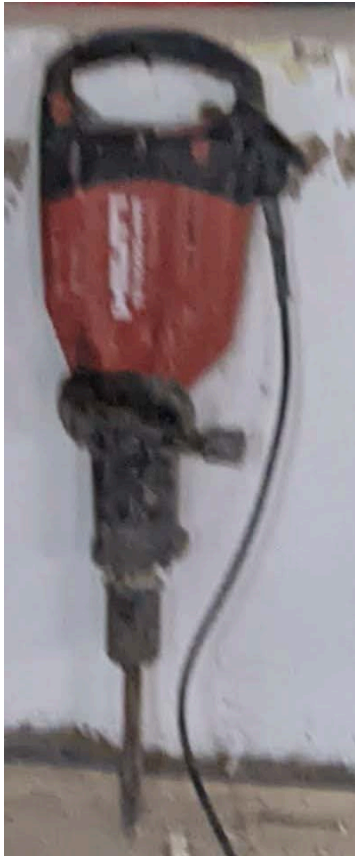
A4.4: Hilti Percussive Breaker

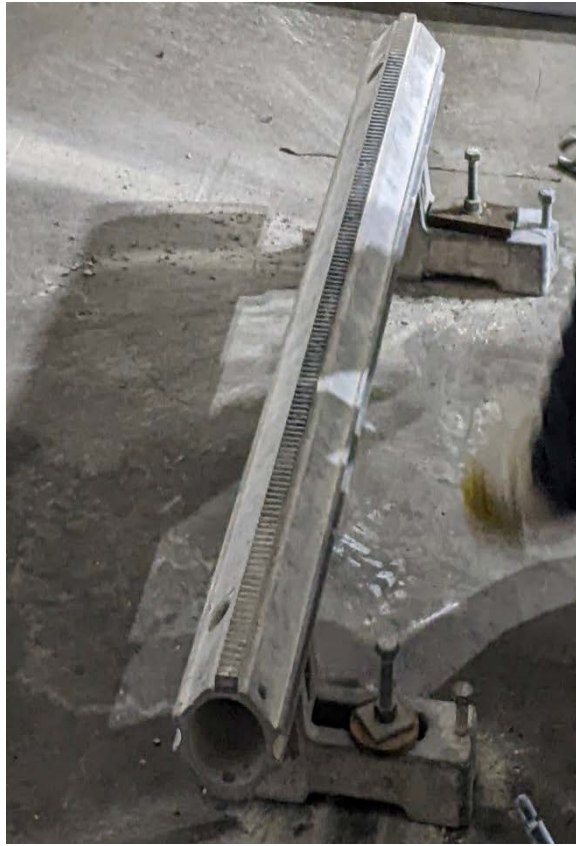
A4.5: Floor Saw Track

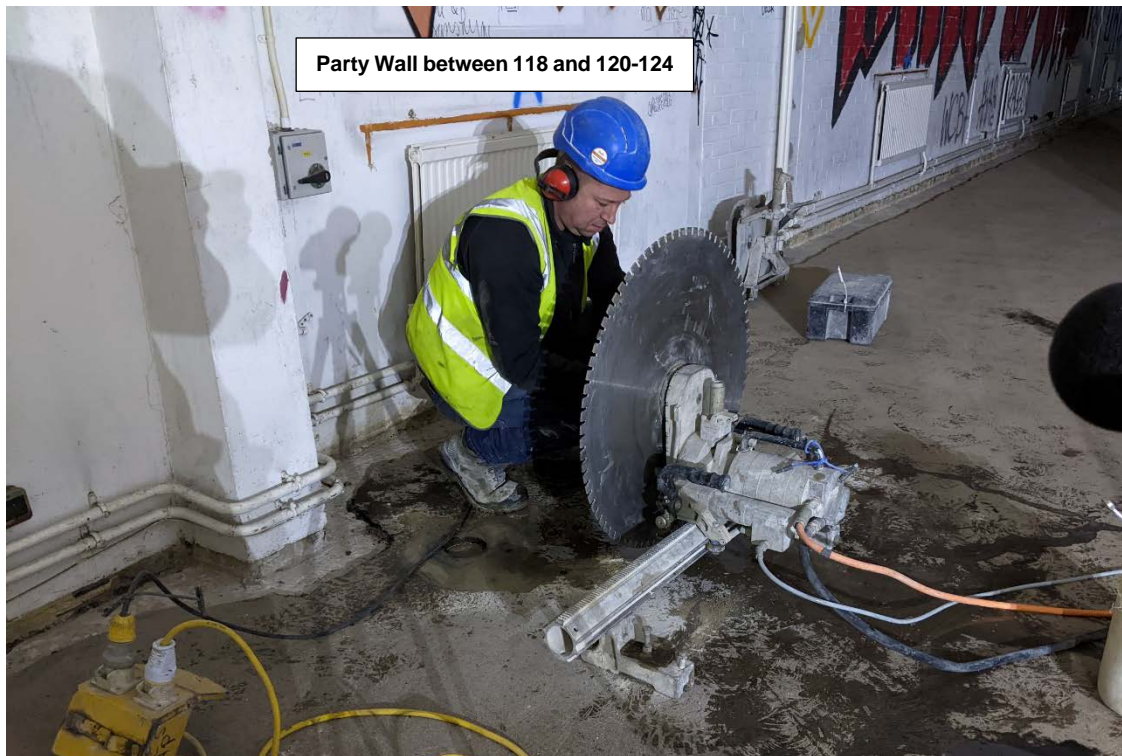
A4.6: Floor Cutting (Ground Floor)

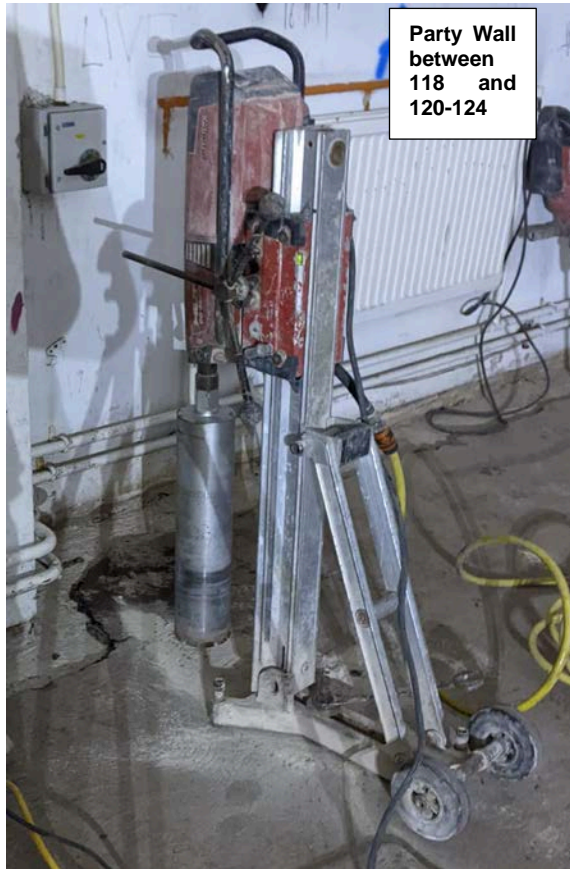
A4.7: Stich (core) Drilling – Ground Floor

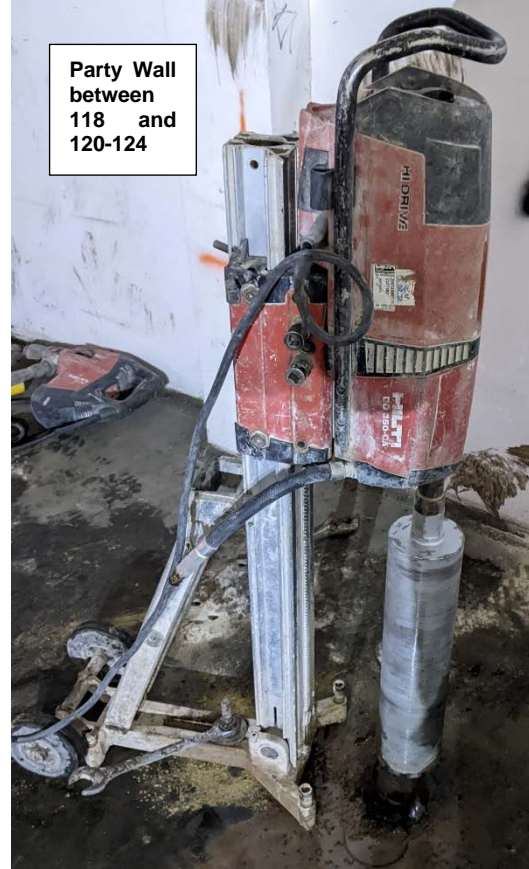
A4.8: Stich (core) Drilling – First Floor

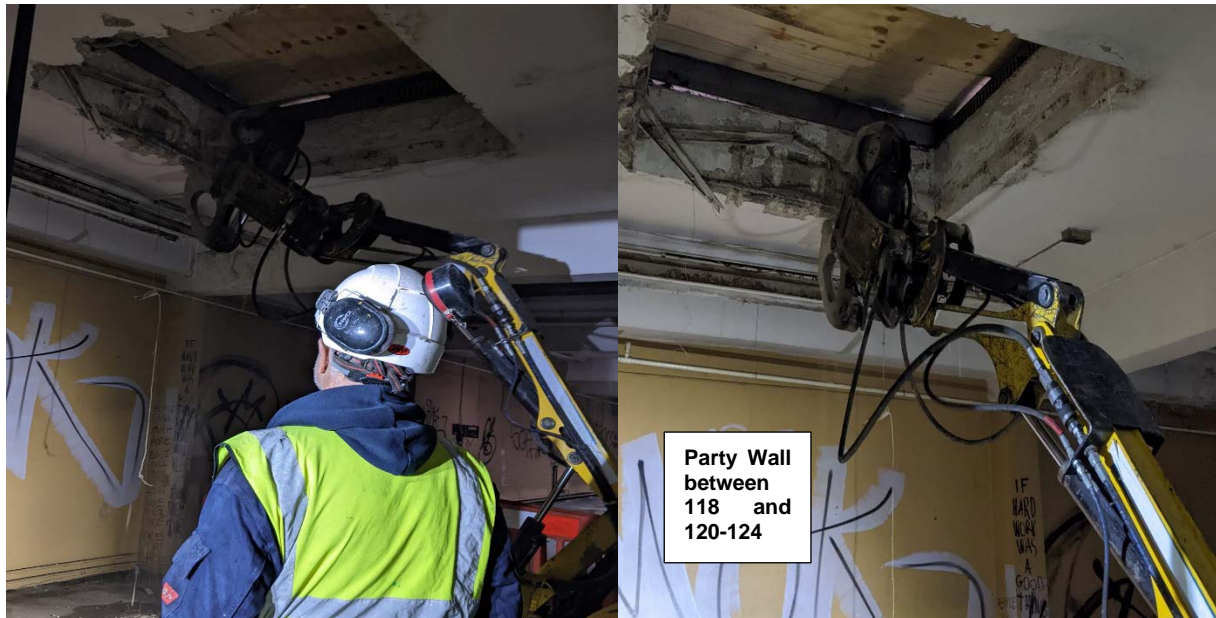
A4.9: Brokk 90 – Slab breaking, First Floor Roof

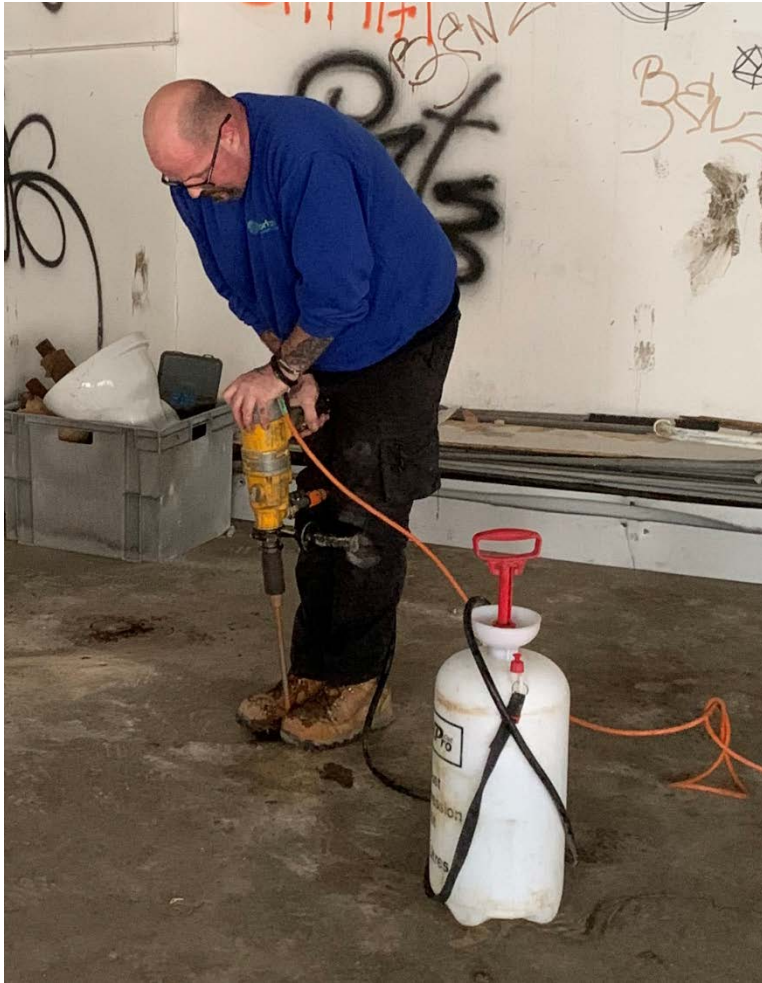
A4.10: Handheld Core Drill – creating temporary bolt holes

- 7.4 Table 7.1 confirms that handheld core drilling, used to form the temporary anchor points (holes) to anchor the track or frame, generates noise levels (at source) that do not exceed those measured for stitch core drilling. Given that it has been established stitch core drilling can meet the NR 15 L_{eq} limit as defined in Condition 15 (a)(i), then it is reasonable to consider and conclude handheld core drilling can also satisfy this limit.
