**TREE DEVELOPMENT REPORT**

(BS5837:2012 ARBORICULTURAL IMPACT ASSESSMENT)

<b>OUR REFERENCE</b>	186879
<b>CLIENT</b>	Edgley Design
<b>PLANNING AUTHORITY</b>	Hackney Borough Council
<b>SITE</b>	64 Middleton Road
<b>SURVEY &amp; REPORT BY</b>	Paul Roberts
<b>DATE</b>	17 <sup>th</sup> December 2021

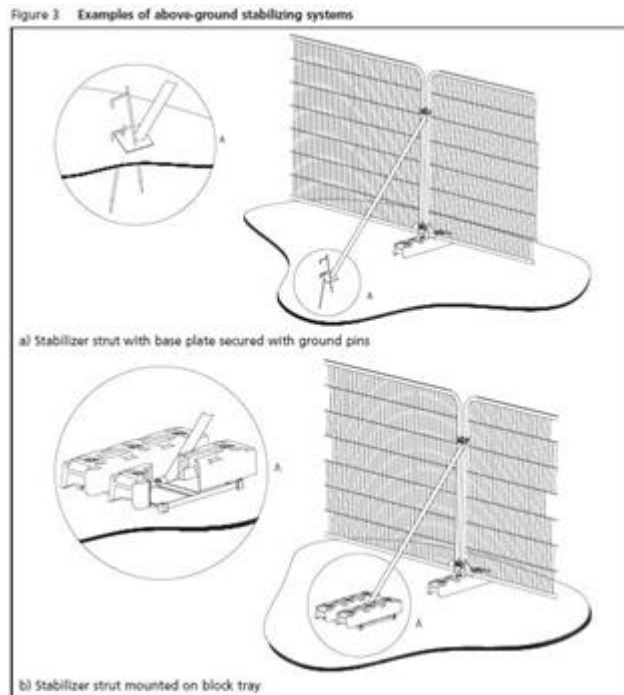
Figure 1 - Identifying tree protection fencing design.

The barrier fencing is to be installed as per figure 3 of the BS 5837:2012 using standard 2-metre-tall by 3.5 metres wide welded mesh panels on rubber or concrete feet secured with ground pins.

All fencing will need to be erected prior to any construction works commencing and will remain intact until all works are completed on site. The protected area must be regarded as sacrosanct and should not be removed or altered without prior recommendation by the project arboriculturist.
